## Soil and Water Conservation in Thika-Chania catchment, Kenya

### Abstract

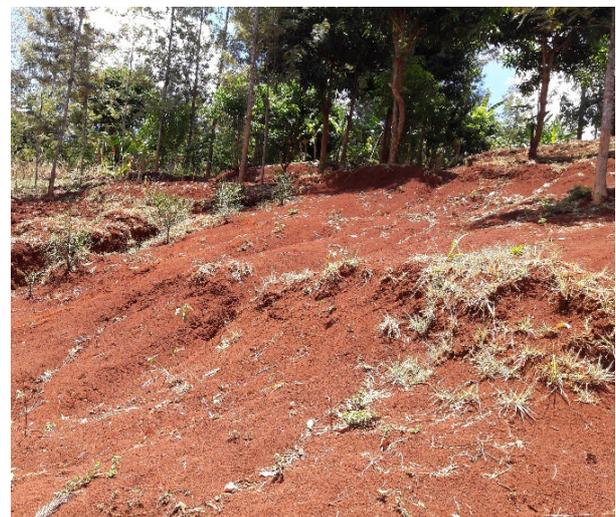
Terraces were commonly found in the coffee growing zones. The terraces are however not managed properly leading to their collapse and the soils washed away by surface runoff as shown in Figures 6 and 7.

Figure 6. Collapsed terraces in Gatura village.

For their optimal operation, terraces need to be rehabilitated and encourage construction of new ones in areas where none exists. Based on a study done in Ethiopia, the lack of short term benefits from conservation measures could be attributed to the lack of maintenance of terraces [11]. This is evident in areas where grass strips are well maintained because they are a source of fodder for livestock.

Research shows that when soil and water conservation measures are improved, they can reduce moisture stress and improve crop yields associated with rain-fed agriculture [17]. Surface erosion was evident in sloping areas where gullies have already developed Figure & 7. From the baseline survey, it was observed that more than half of the respondents (51%) had less than a quarter of their lands with soil conservation measures.

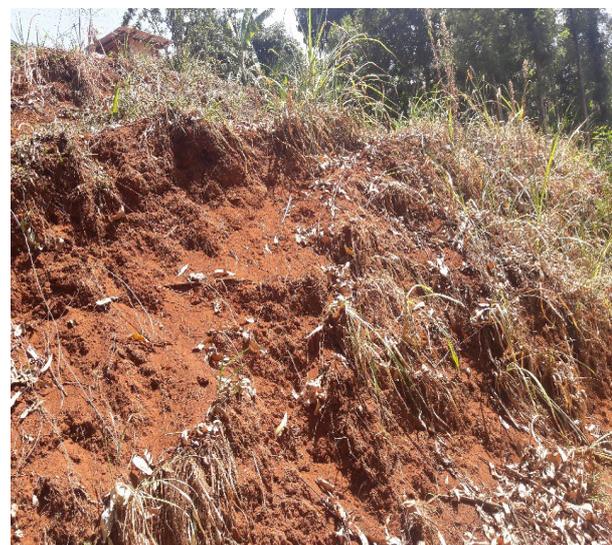
Figure 7. Degraded grass terrace in Gatura village.
